# Manhole Inspection Summary

Manhole # S02II2008MH

Insp Date: **7/17/06 8:38 AM**

**Location** Address: **3113 Shelburne Rd**

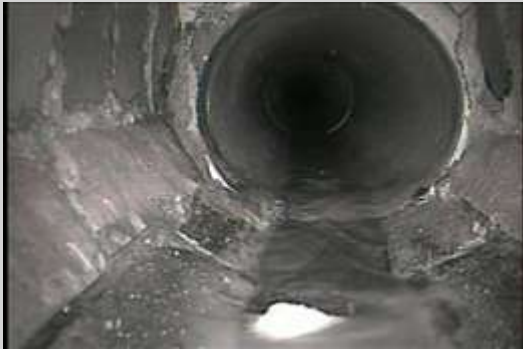
### 8 in. Circular Gravity Sewer Pipe Out @ 12 O'Clock

Deposits: ☐ None ☐ Mud ☒ **Sludge** ☐ **Debris** ☐ Grease

Silt Depth: **0.125** (in.) Deposits Extent: **Light**

Infiltration: **None** Pipe Seal Cond: **Sound**

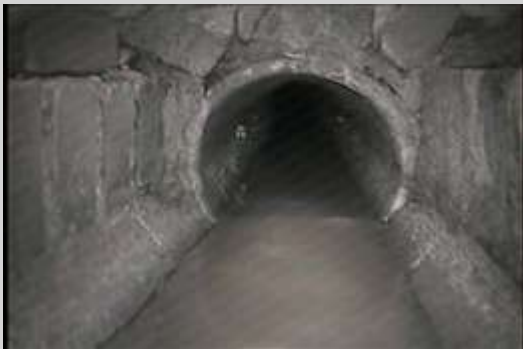
### 8 in. Circular Gravity Sewer Pipe In @ 6 O'Clock

Deposits: ☐ None ☐ Mud ☐ Sludge ☒ **Debris** ☐ Grease

Silt Depth: **0.125** (in.) Deposits Extent: **Light**

Infiltration: **None** Pipe Seal Cond: **Sound**
